**Report Number: 214-TRC-03-004**

**Safety Compliance Testing For FMVSS 214**

**Side Impact Protection**

**2003 Mazda 6 4-door**

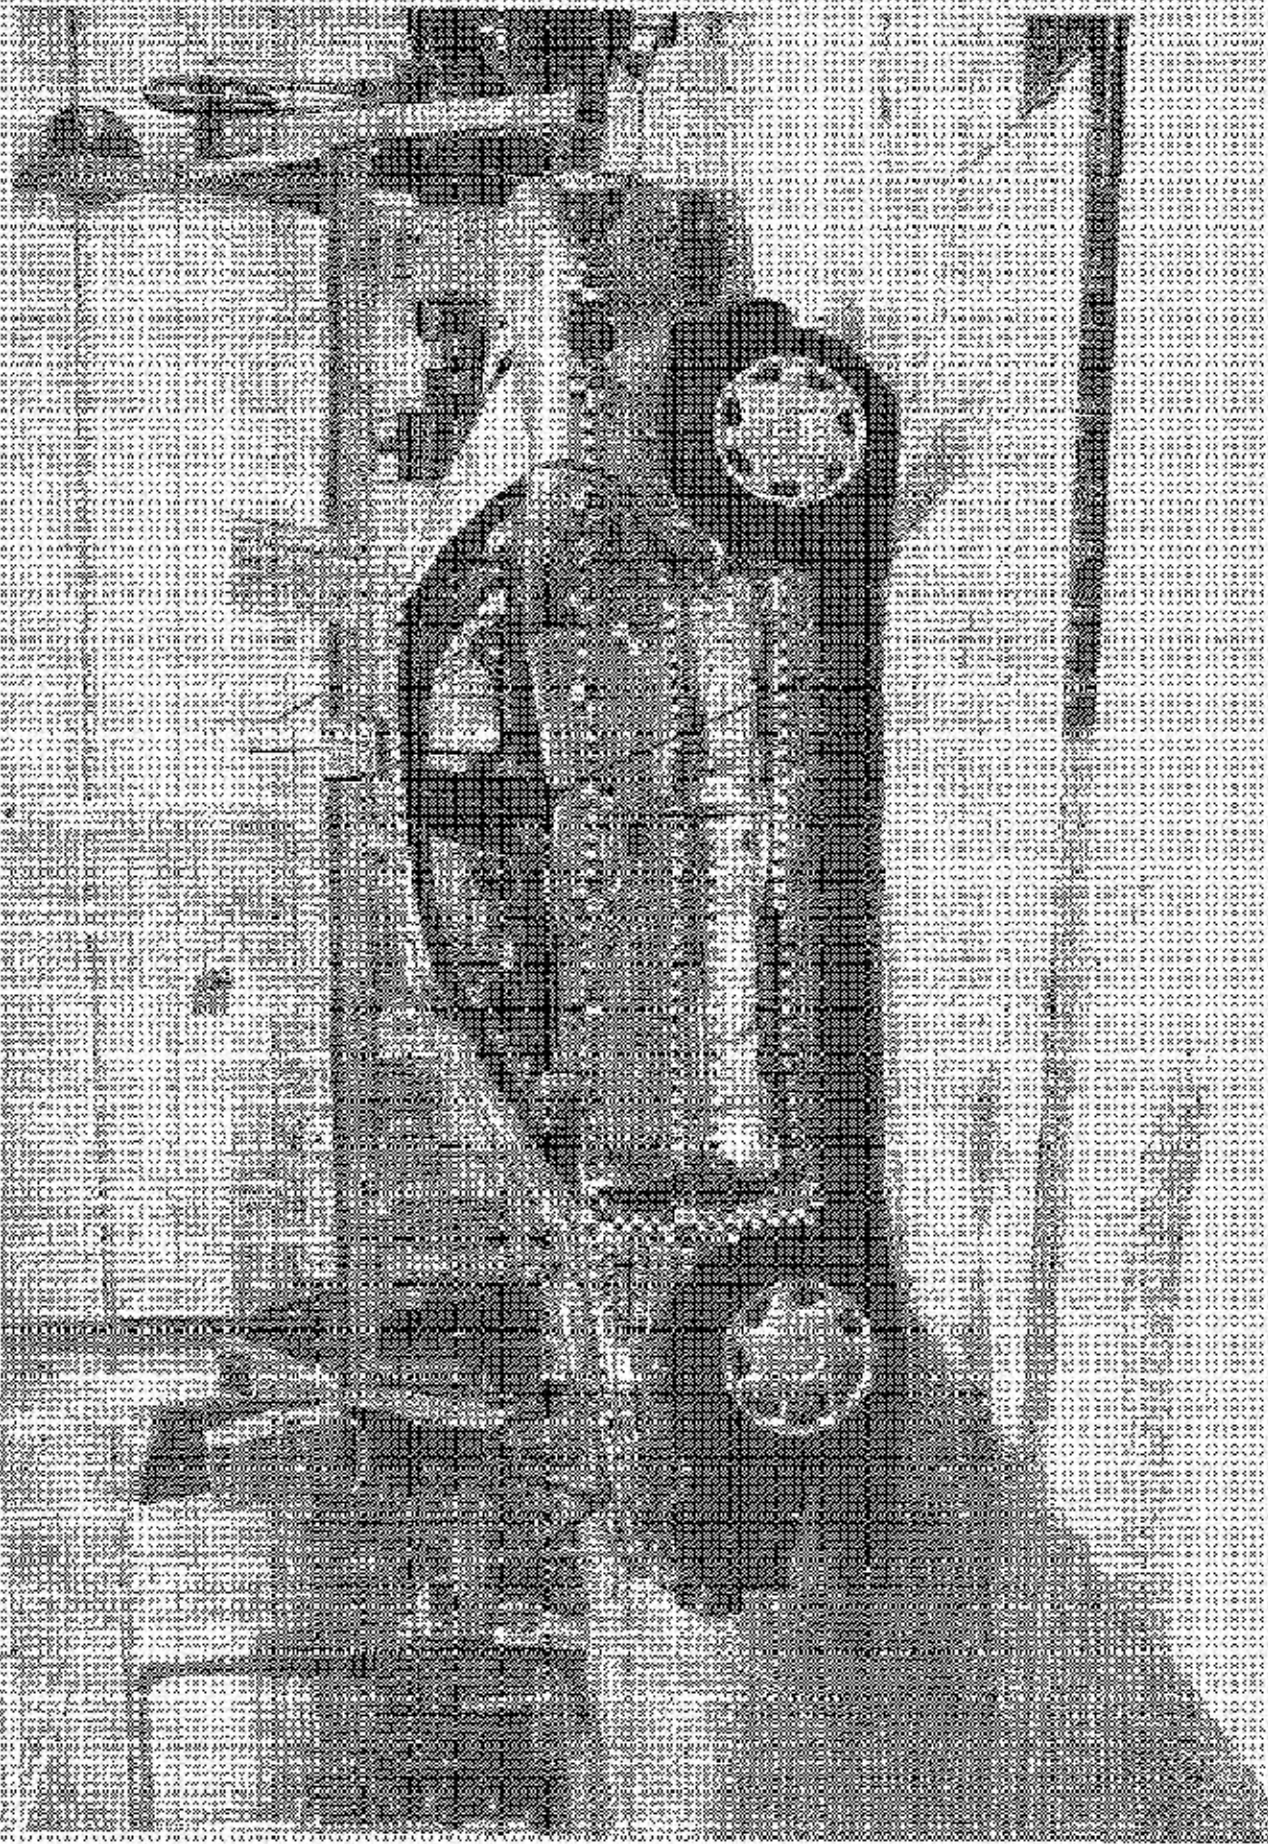
Figure A-2. Post-Test Impacted Side View of Test Vehicle

Windshield: Small crack at upper A-pillar.

Window: Driver side, passenger side and rear window broken out.

Full length of induced damage was 0 to 2250 mm.
